SUMMARY REPORT

Inspection Address: 345 Apartment Way, Reno, NV 89500
Inspection Date: 4/19/2011 Start: 9:30 am

CONFIDENTIAL INSPECTION REPORT

345 Apartment Way, Reno, NV 89500

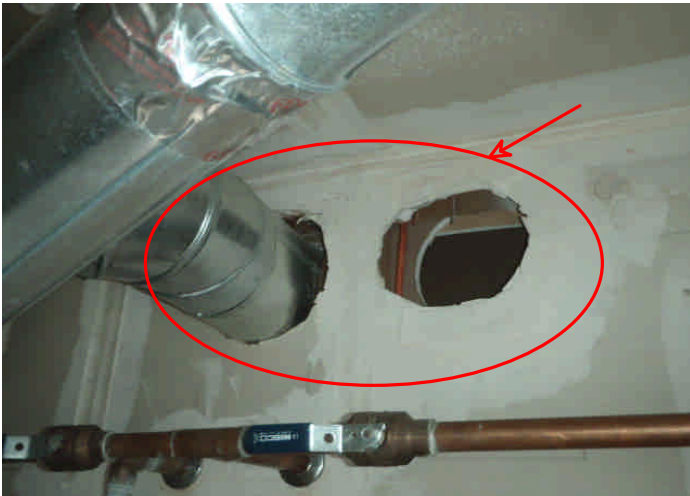
- There is a breach of the necessary firewall separation in the water heater closet of building B that should be corrected.

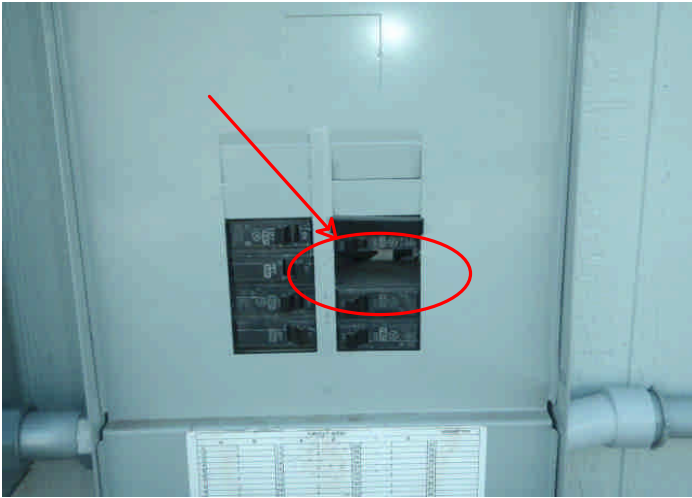
- There are voids or open knockouts in the interior cover of the electrical sub-panel at the exterior of building D that should be covered.

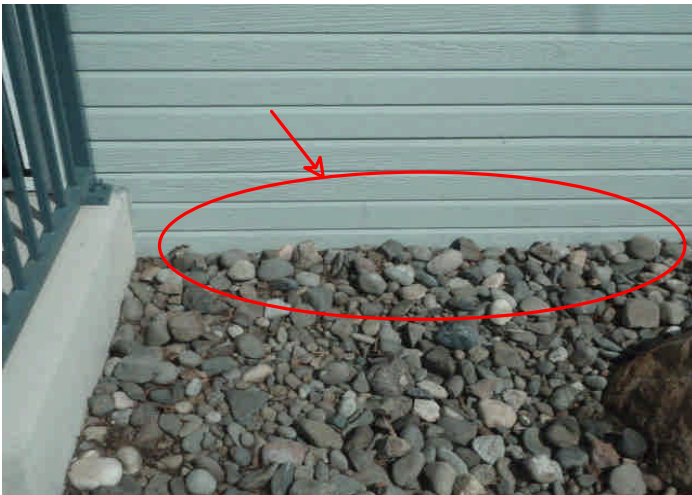
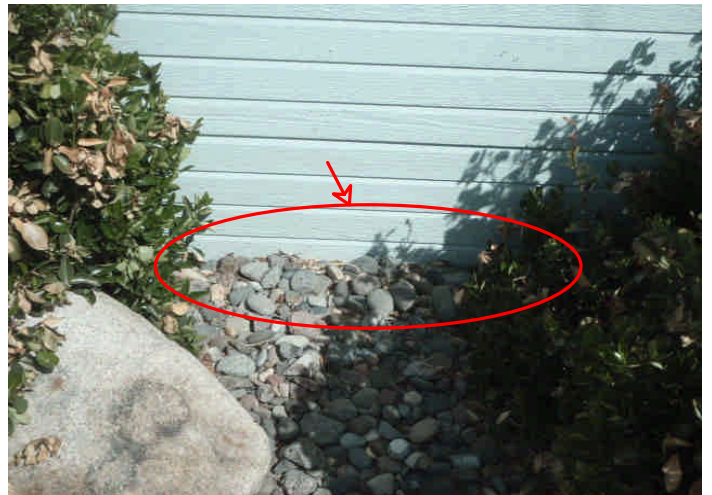
- Soils and/or landscape materials in contact with the bottom of the siding at the south side of building D should be pulled away to prevent moisture damage.

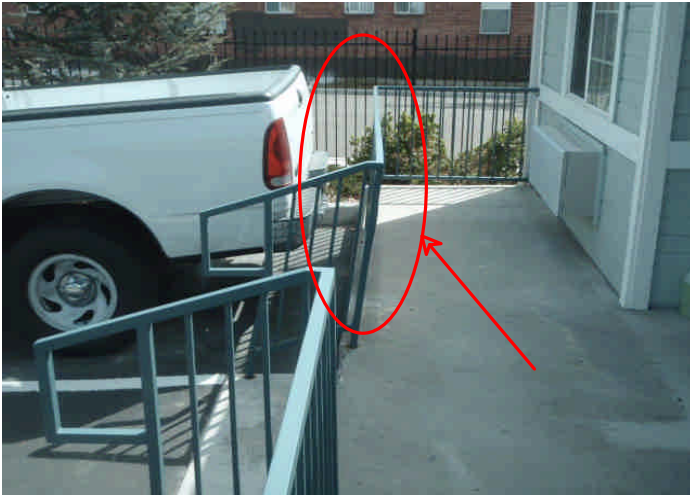
- The walkway handrail outside unit 101 at building B is impact damaged.

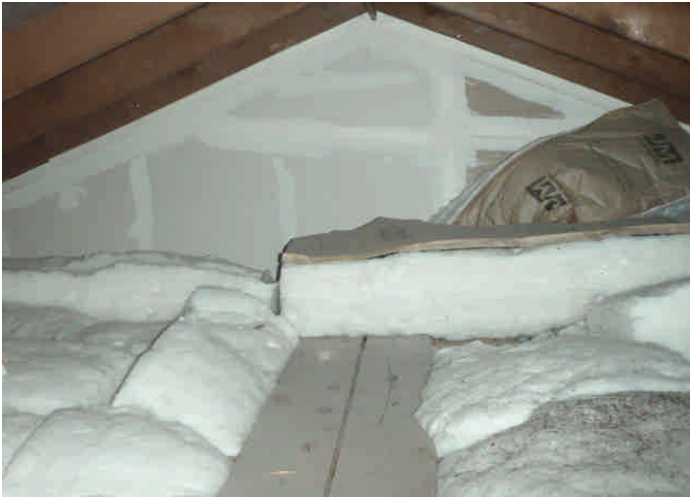
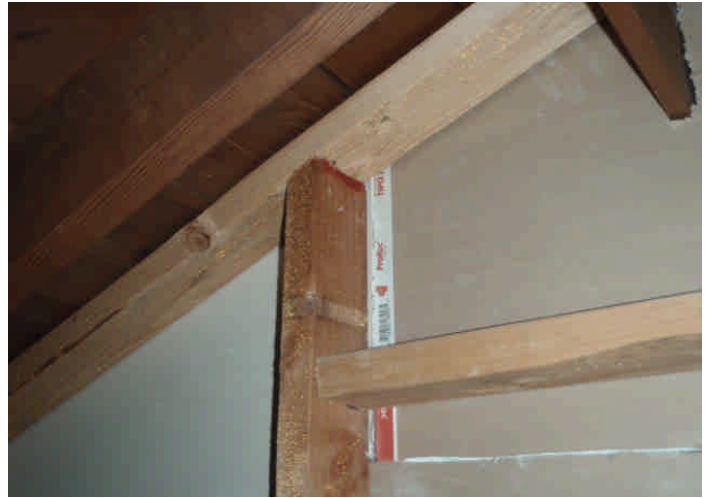
- There is no attic access visible for the attic spaces in buildings C and D. Access to attic spaces in building B was limited to the attics over two of the units. These units have firewall separations installed that prevent full access to other areas. Consequently, roof framing, insulation values, ventilation and other components of the attics was not inspected. Access should be provided or identified and all attic areas should be fully inspected.

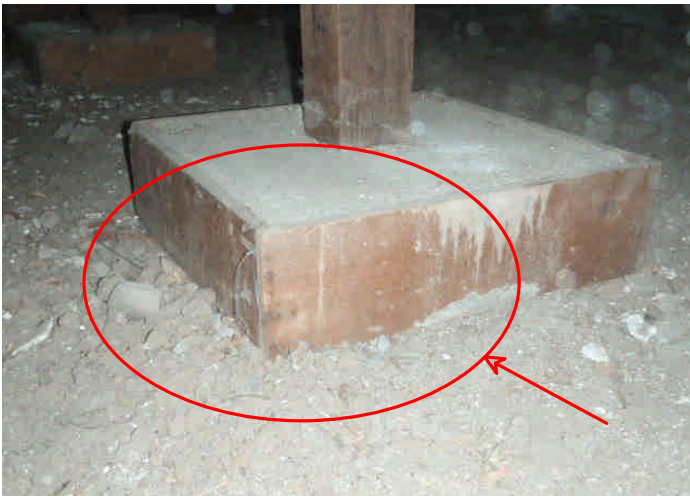
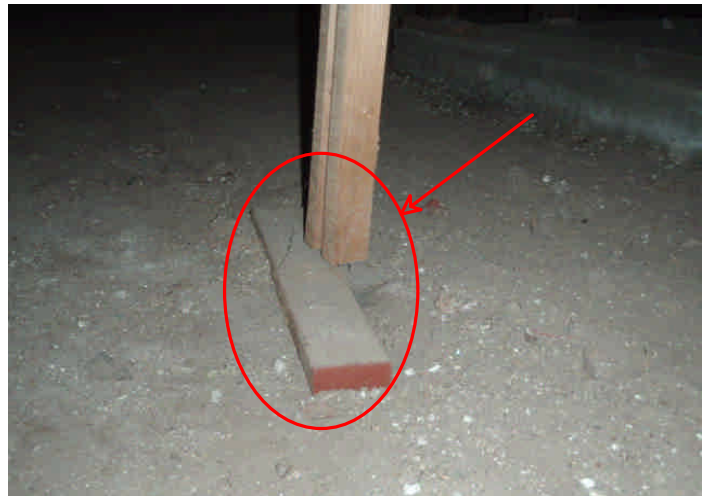
- It is recommended that all cellulose and insulation debris be removed from the crawlspace, including remaining form boards or plumbing support blocks, which should be replaced with proper supports. There is a wood post support under building B that should be replaced with a proper pier.

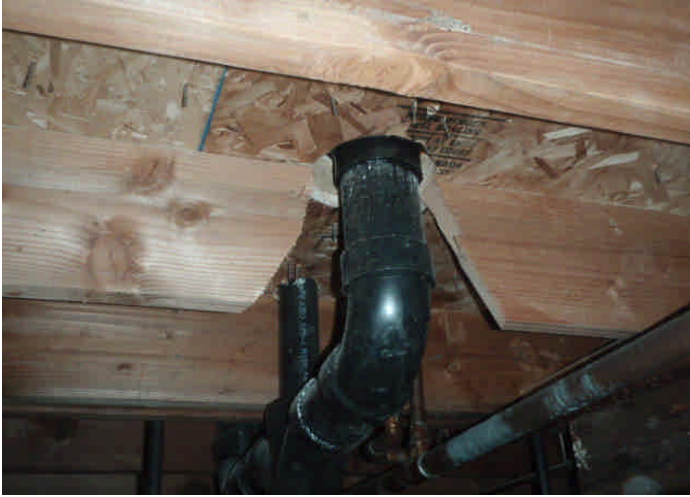
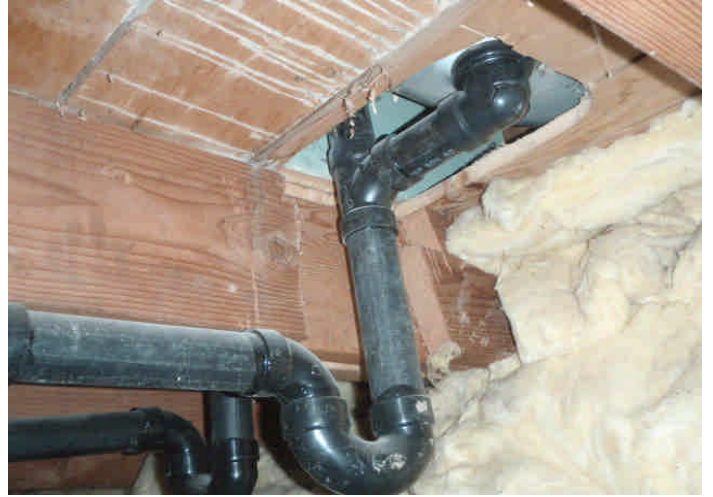
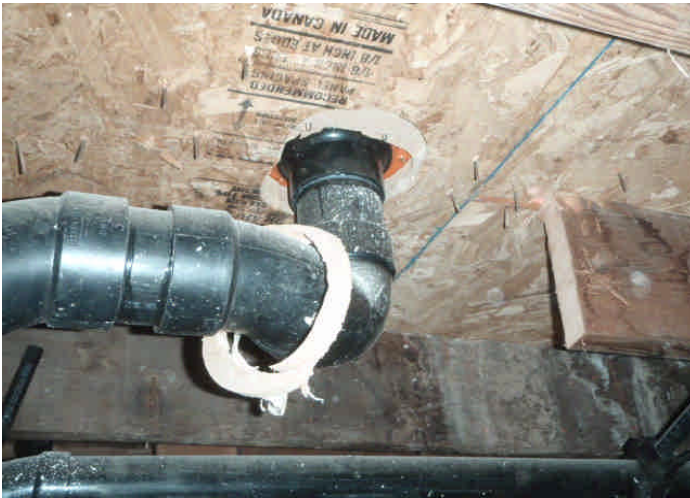
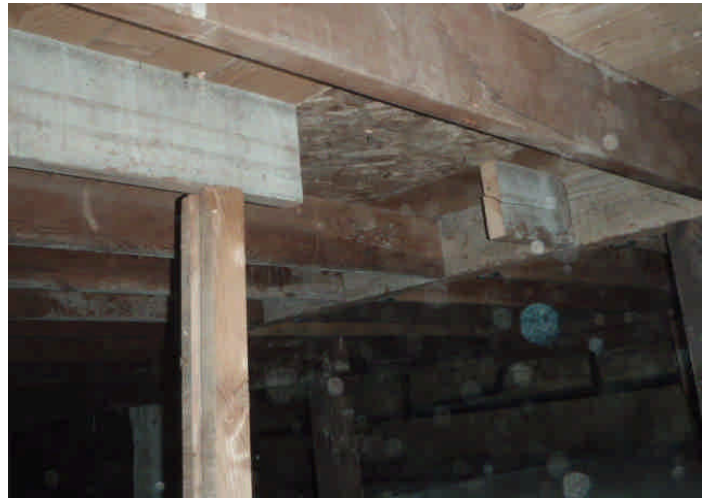
- There is evidence of extensive floor framing repairs at buildings B and C, as visible from the crawlspace. There are numerous cut or improperly modified joists noted at building B that should be assessed and repaired by a licensed general contractor. There is an area under the kitchen of unit 110 in building B that has insufficient floor sheathing, resulting in a very soft floor area, that should be repaired. Photos below are examples of faults - additional faults exist.

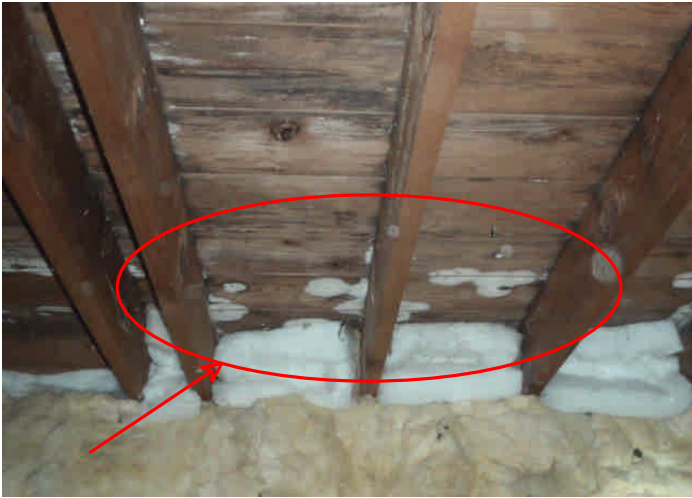
- There is discoloration and fungus on some of the sub floor framing in the crawlspace of building B due to excessive moisture that should be further assessed and treated as necessary by a licensed pest control company. Rim joist insulation prevents complete evaluation and should be removed for effective review of the floor condition.

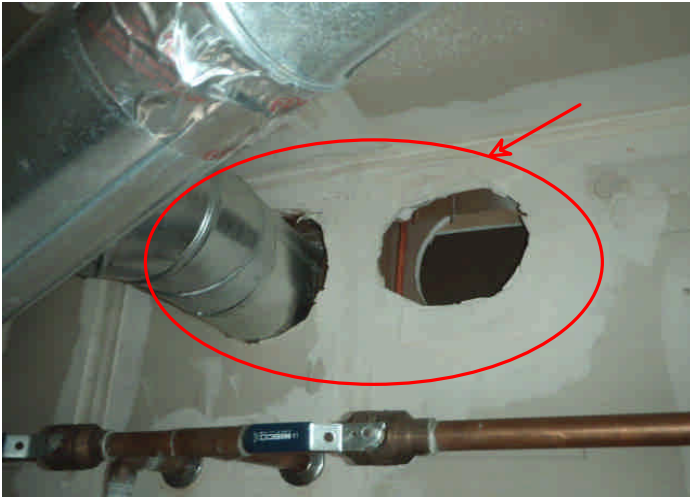
There is a breach of the necessary firewall separation in the water heater closet of building B that should be corrected.

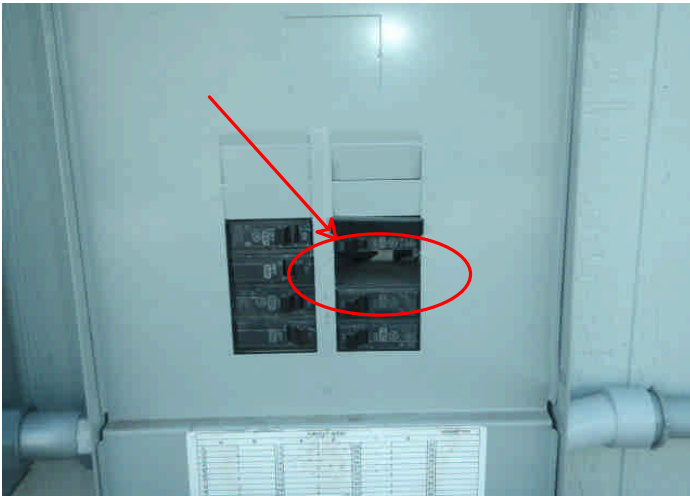
There are voids or open knockouts in the interior cover of the electrical sub-panel at the exterior of building D that should be covered.

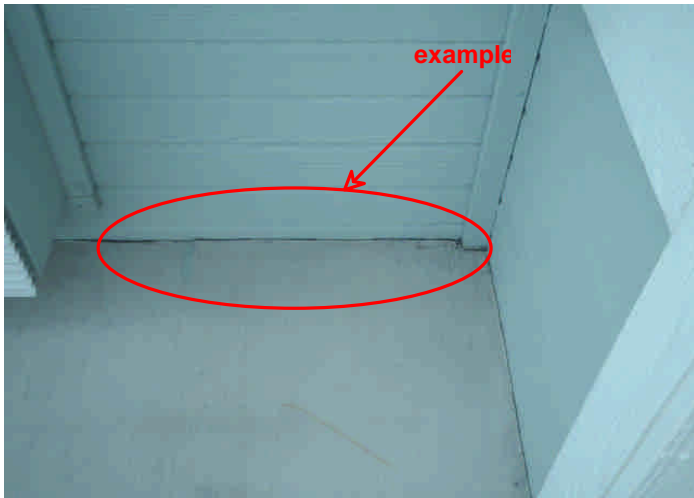
The exterior walls of all buildings are clad with a hardboard type siding. Concrete walkways have been poured over the bottom edge of the siding in some areas which can allow for excess exposure to moisture. These areas should be kept well sealed and be monitored.

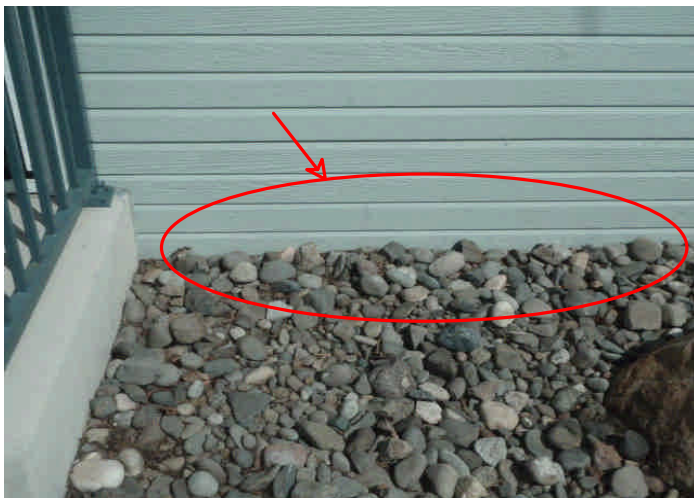
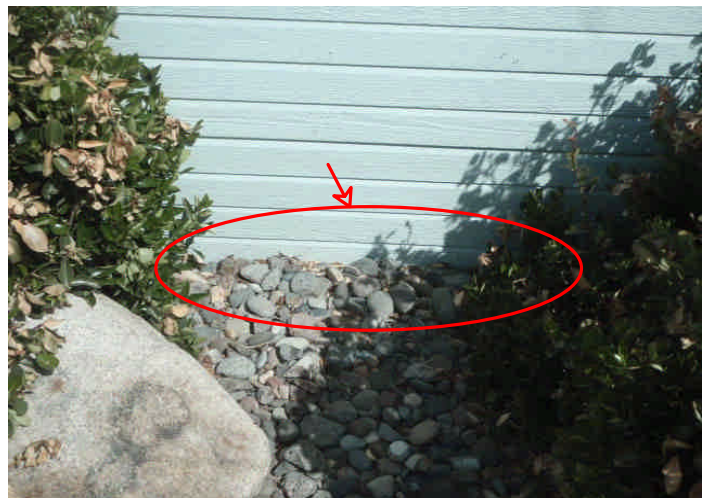
Soils and/or landscape materials in contact with the bottom of the siding at the south side of building D should be pulled away to prevent moisture damage.

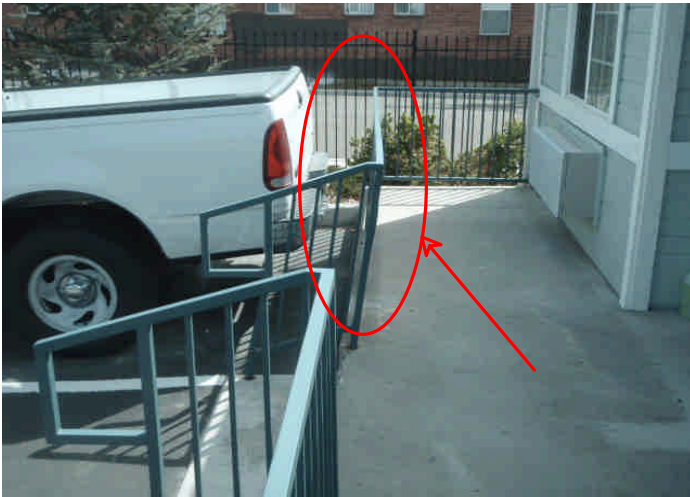
The walkway handrail outside unit 101 at building B is impact damaged.

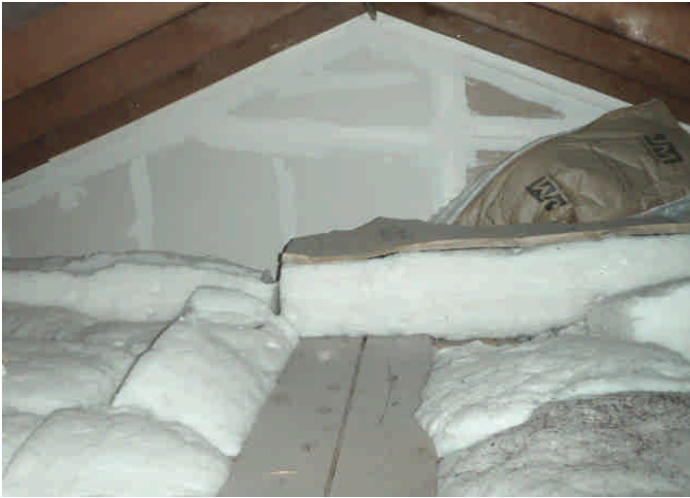
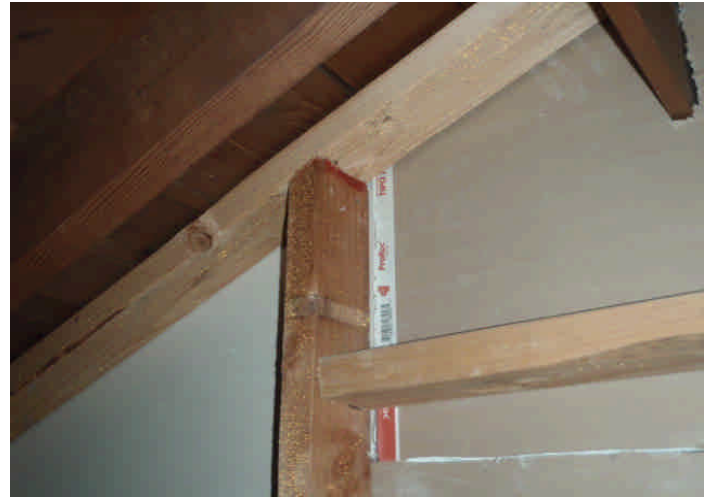
There is no attic access visible for the attic spaces in buildings C and D. Access to attic spaces in building B was limited to the attics over two of the units. These units have firewall separations installed that prevent full access to other areas. Consequently, roof framing, insulation values, ventilation and other components of the attics was not inspected. Access should be provided or identified and all attic areas should be fully inspected.

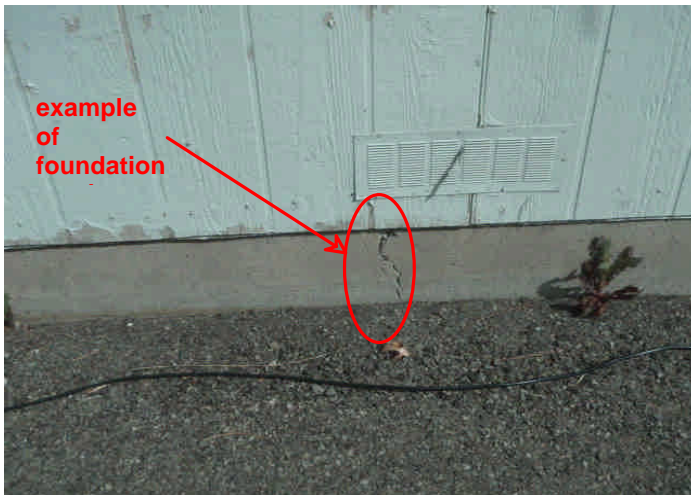
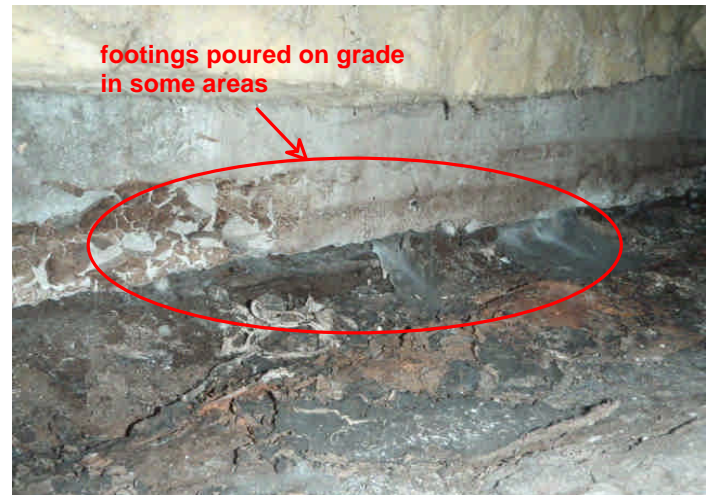
Minor cracks in foundation walls, which are constructed of both poured concrete footings and CMU type block, are noted, as at the south side of building C. Common defects, and cracks or deviations from plumb or level are only reported if they appear to need further evaluation. Small foundation cracks should generally be sealed against moisture penetration and monitored for changes. Any significant changes should be further evaluated by qualified contractors or engineers.

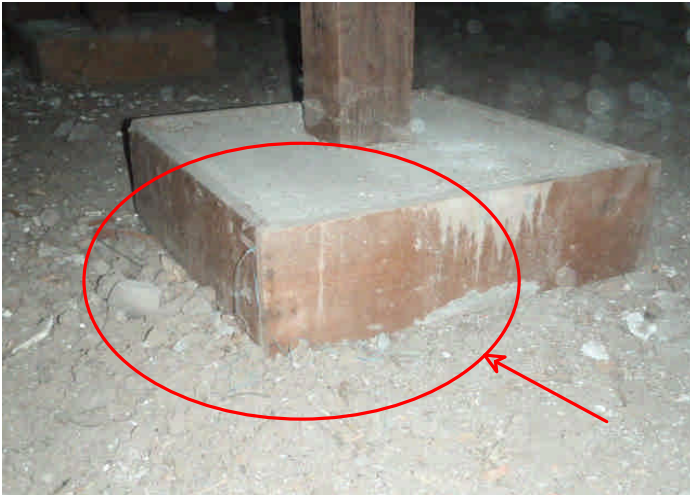
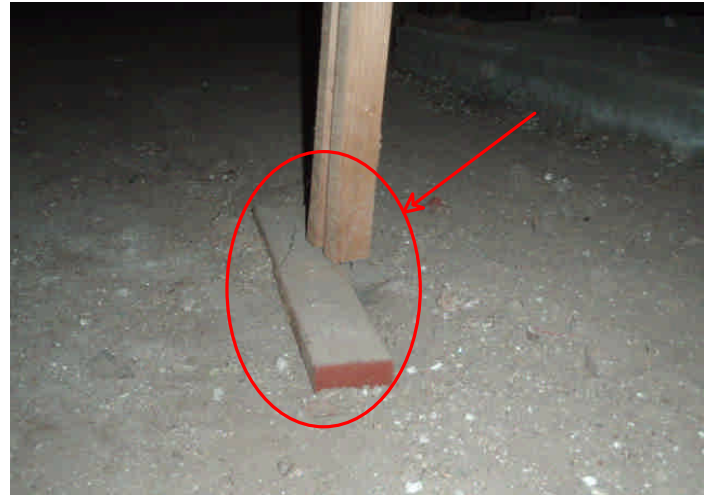
It is recommended that all cellulose and insulation debris be removed from the crawlspace, including remaining form boards or plumbing support blocks, which should be replaced with proper supports. There is a wood post support under building B that should be replaced with a proper pier.

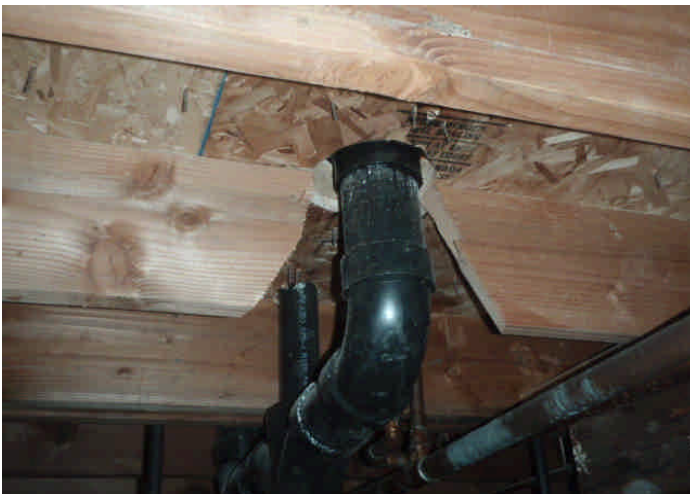
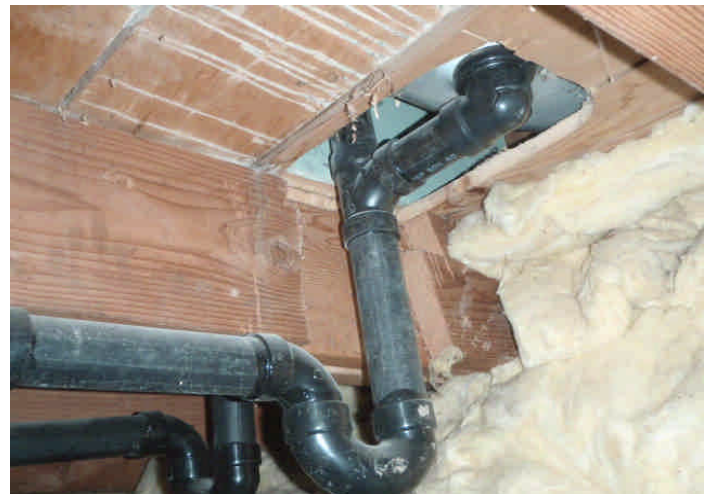
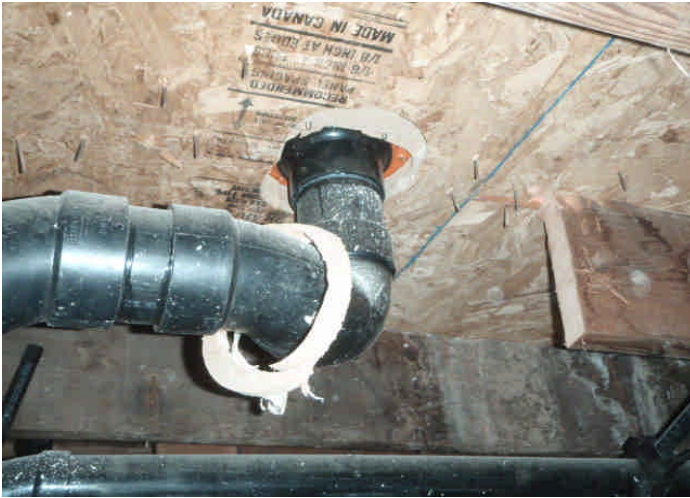
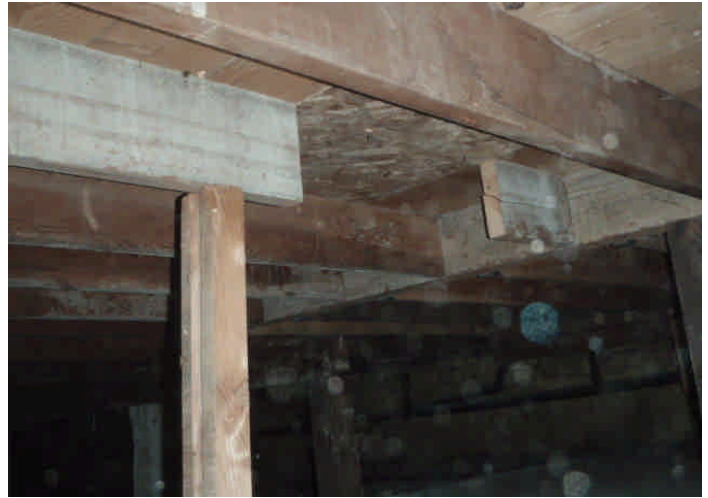
There is evidence of extensive floor framing repairs at buildings B and C, as visible from the crawlspace. There are numerous cut or improperly modified joists noted at building B that should be assessed and repaired by a licensed general contractor. There is an area under the kitchen of unit 110 in building B that has insufficient floor sheathing, resulting in a very soft floor area, that should be repaired. Photos below are examples of faults - additional faults exist.

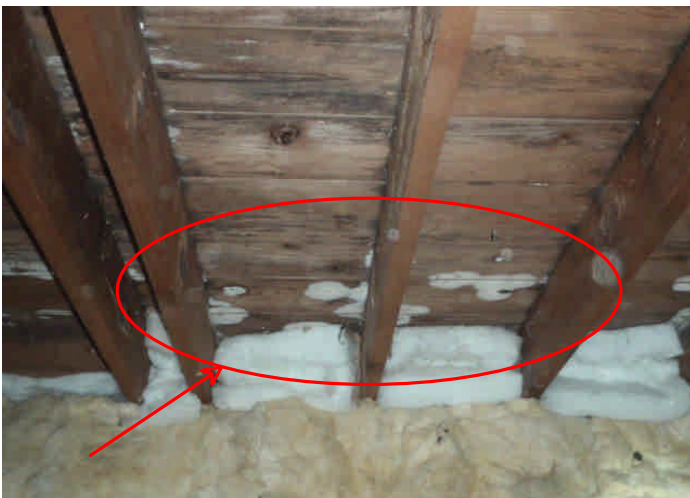
There is discoloration and fungus on some of the sub floor framing in the crawlspace of building B due to excessive moisture that should be further assessed and treated as necessary by a licensed pest control company. Rim joist insulation prevents complete evaluation and should be removed for effective review of the floor condition.
